No. 3

**Airbus A300B2, EP-IBU, accident in the vicinity
of Qeshm Island, Islamic Republic of Iran on
3 July 1988. Report released by ICAO.***

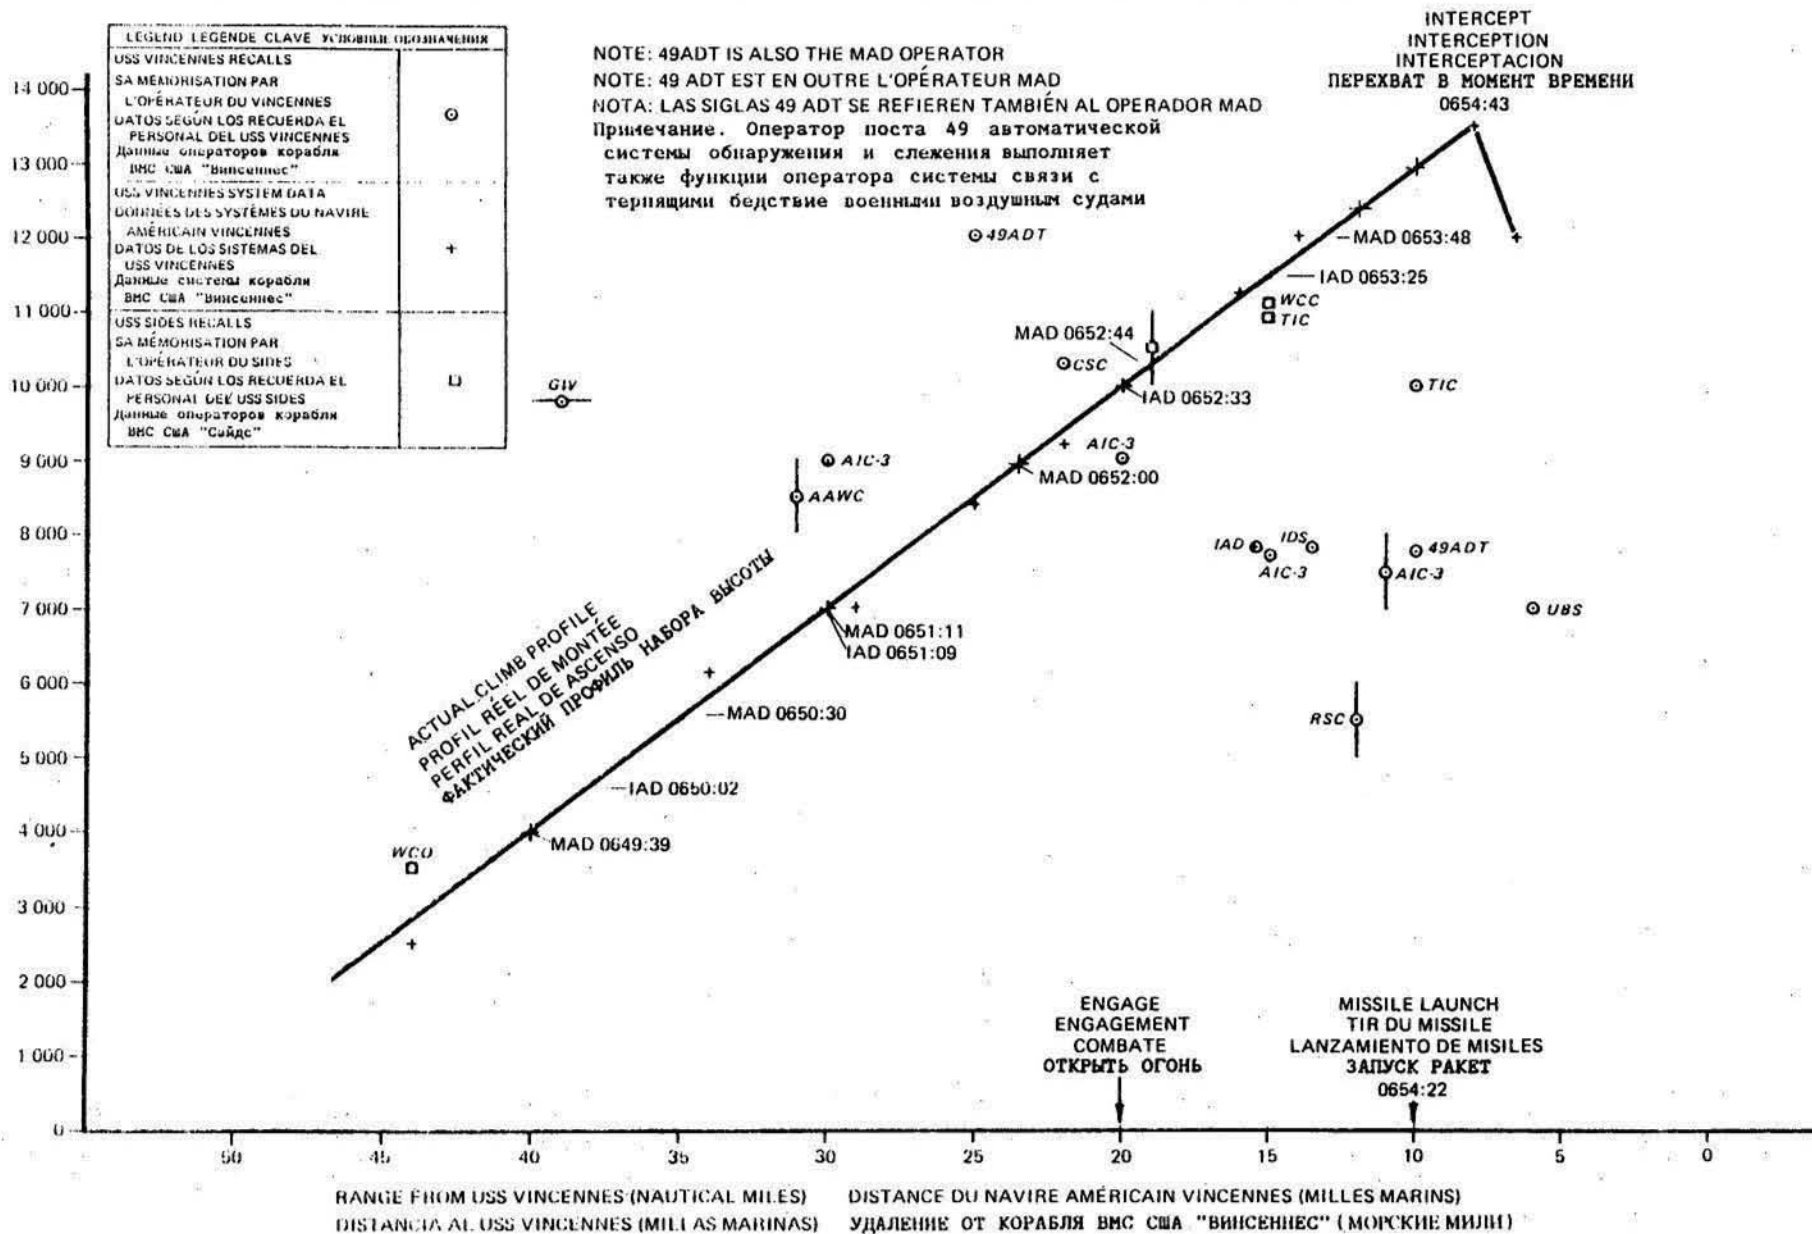
FIGURE 1: Flight profile of IR655
 FIGURE 1: Profil du Vol IR655
 FIGURA 1: Perfil de vuelo del IR655

1.1.5 At 0654:43 the aircraft was destroyed by two surface-to-air missiles whilst climbing from FL120 to FL140 well within airway A59 south of MOBET, in the vicinity of Qeshm Island.

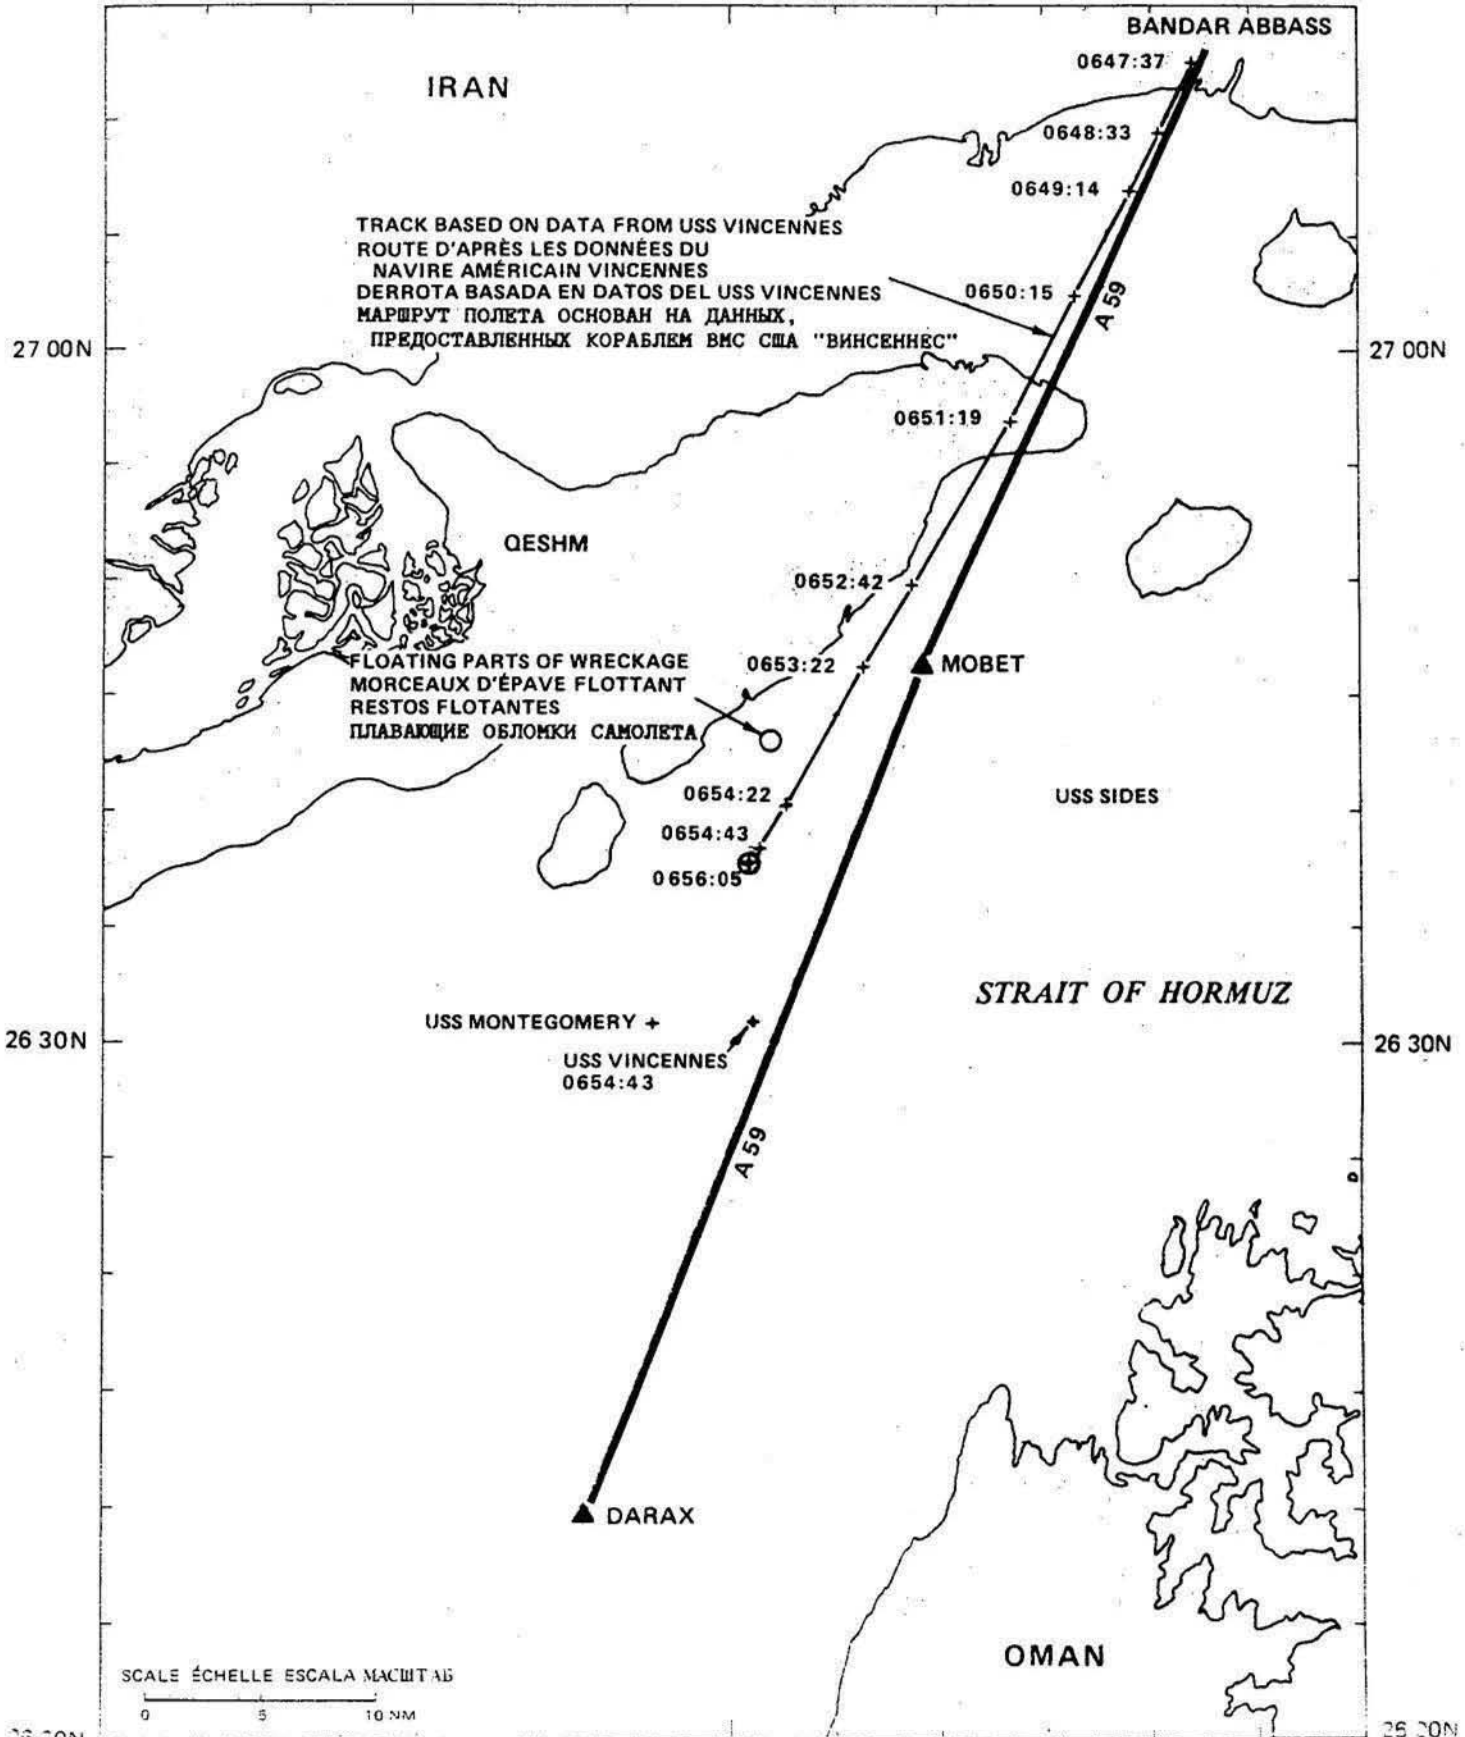
FIGURE 2: Track of IR655
 FIGURE 2: Route d'IR655
 FIGURA 2: Derrota del IR655

2.11.9 Most of the recovered bodies and floating parts of the aircraft were found in an area around 26 43 N, 056 02 E. Taking into account an estimated 3 kt tidal flow towards the west as given by USS Vincennes, this would indicate a position of impact with the sea in an area some 5 NM south-southwest of MOBET.
